SPOKANE INDIAN HOUSING AUTHORITY TRIP REPORT

Assessment of Mold and Moisture Conditions

Final Report

March 15 - 16, 2005

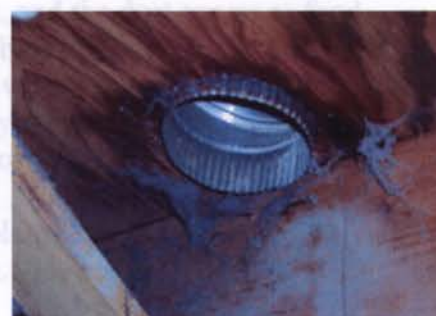
Figure 6: Disconnected dryer duct

One dryer vent was disconnected. Reconnect it with smooth metal ducting. Install a dryerbox to help make the transition if the dryer is located in a laundry room (Figure 14). Cost is about \$20 (www.drybox.com).

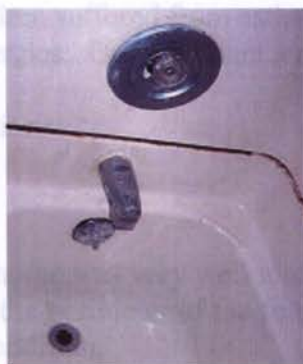
Figure 2: Mold at tub to surround junction

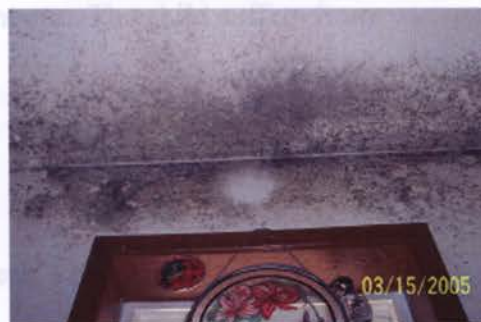
Bathroom: The toilet was securely fastened to the floor. The bath fan, operated by a separate switch, exhausted with very low efficacy to the outside. The bathroom grill was clogged (Figure 5). There was extensive mold on the bathroom ceiling, particularly along the exterior wall

Figure 1: Mold at wall to ceiling junction in bathroom

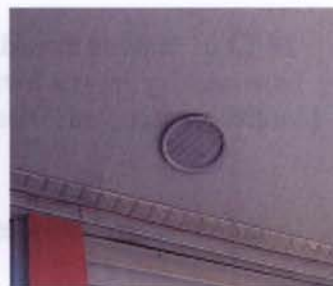
Figure 5: Bath exhaust vent in soffit

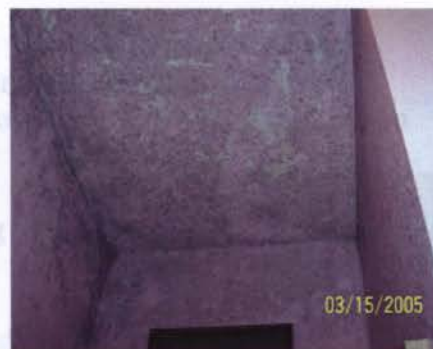
Figure 2: Bath ceiling and walls consumed by mold

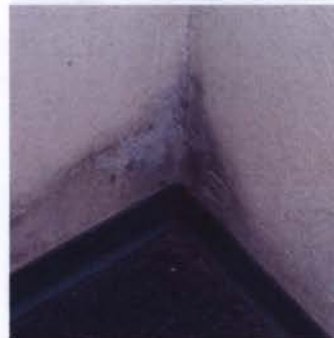
Figure 3: Mold at base of wall in bedroom exterior corner

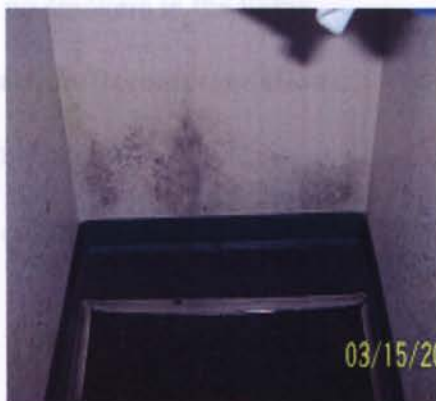
Figure 4: Mold on closet wall

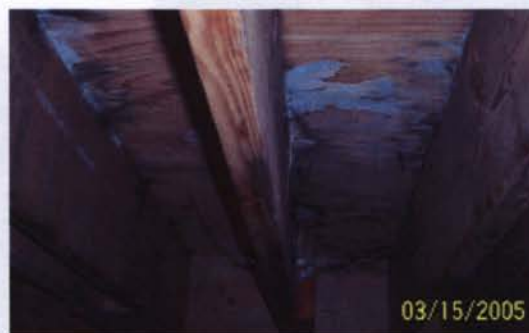
Crawl Space Conditions: The crawl space was dry, and the vents were closed, however there was evidence of former flooding. The walls were insulated, and a vapor barrier was installed. Below the bathroom was evidence of water from above (Figure 5).

Figure 5: Evidence of water migration from bathroom above into the crawl space

10. Use electric in-wall heaters in bedrooms to increase wall surface temperatures, or use a dehumidifier to lower the humidity in these rooms.
11. Replace the dryer duct in the crawl space.
12. Identify where the plumbing is leaking and repair.
13. Install a minimum of 1" thick rigid insulation tight to the subfloor at each crawl space vent extending approximately 2' beyond the rim joist.
14. Remove the clutter in the crawl space, or place it in sealed plastic containers. Clutter in the crawl space provides food for mold to grow on if the humidity gets high enough.
15. Repair or replace the non-functioning kitchen range hood.
16. Repair hole in roof.
17. To remedy the condensation on the toilet tank, install a mixing valve or an insulated toilet tank.

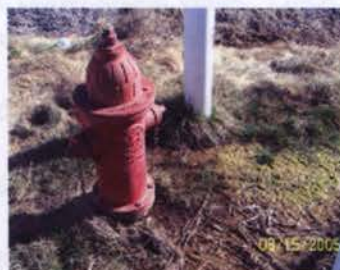
Figure 4: Leaking fire hydrant in front of house

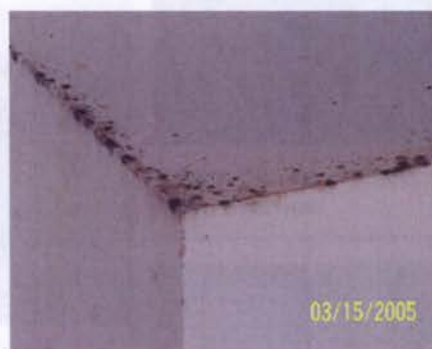
Figure 2: Mold at wall to ceiling junction above bathtub

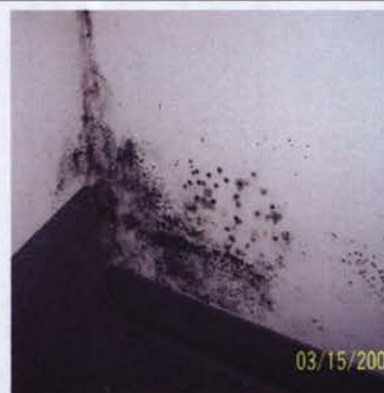
Figure 3: Mold at base of wall in exterior corner

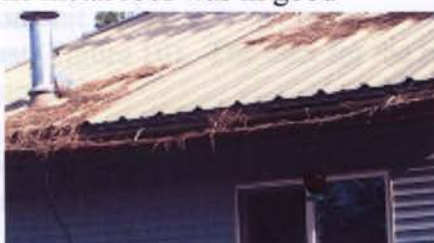
Exterior Conditions: The metal roof was in good condition. The gutters were full of pine needles and appeared to be peeling away from the fascia board (Figure 5). The vinyl siding was cracked in

Figure 5: Gutters full of pine needles

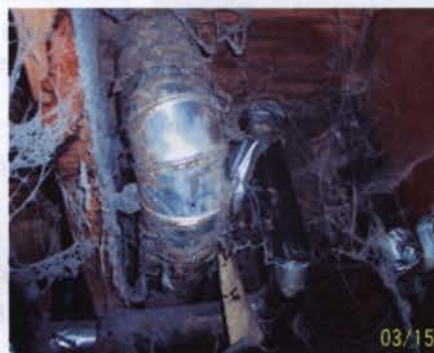
Crawl Space Conditions: The crawl space was dry, and a vapor barrier was present. The stem wall and band joist were insulated, but sections of the band joist insulation were missing in locations difficult to access because of the joists layout. Mold had formed at these locations. No vents were present. Instead, a ventilation system drew air from the habitable spaces into the crawl space and exhausted it into the attic. See the Technical Section of this report for a more complete description of this ventilation scheme. The dryer duct appeared intact, however, based on the amount of lint on the surrounding cobwebs probably leaked into the crawl space (Figure 4).

Figure 4: Dryer vent - note lint on cobwebs

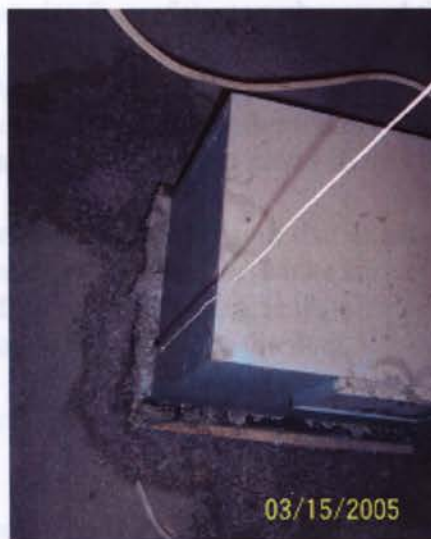
Attic: The attic hatch was insulated. The attic had eight inches of cellulose insulation. The ventilation system for the crawl space was located in the attic. The cellulose insulation surrounding the ventilation unit had been wetted in the past (Figure 10). The duct for the bathroom fan was uninsulated (Figure 11).

Figure 10: Formerly wet insulation in attic next to crawl space ventilator

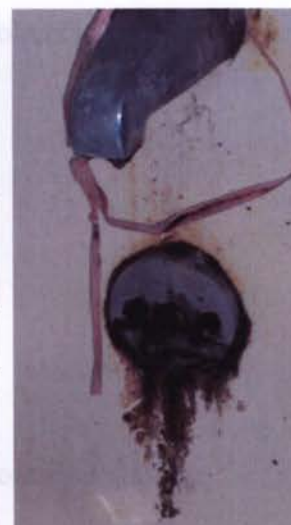
Bathroom: The toilet, replaced a year ago, was securely fastened to the floor. The bathroom fan, operated by a separate switch, was not operable (Figure 7). Mold was present on the drywall above the tub/shower. The junction where the vinyl flooring butted up to the bathtub was compromised and allowed water into the floor system. The tub spigot was leaking (Figure 8).

Figure 8: Tub spigot and overflow

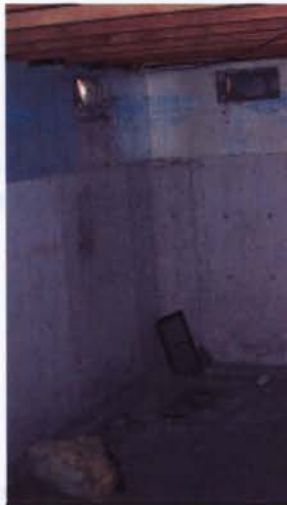
Figure 3: Note mold, insulation and crawl space vent on floor

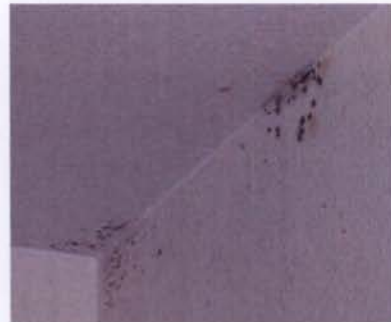
Figure 2: Mold at wall to ceiling junction in bathroom

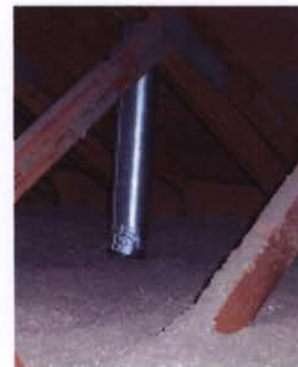
Attic: The attic hatch was insulated. The remainder of the attic had eight inches of cellulose insulation. The bath fan was vented to the outside with smooth uninsulated metal ducting (Figure 11). The ventilation system for the crawl space was located in the attic.

Figure 11: Uninsulated bathroom fan duct

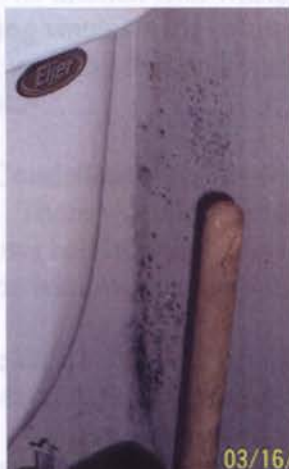
Figure 3: Mold on exterior wall next to toilet

Bathroom: The toilet was not fastened tightly to the floor and there was mold on the wall next to it (Figure 3). The bath fan, operated by a separate switch, was exhausting with very low efficacy to an undersized round vent in the soffit (Figure 7). Mold was present on the bath walls and ceiling. Occupants reported opening the window during showers.
